**DEVELOPMENT OF REPAIR PROCESSES
AND SOURCES FOR B-52 AIRCRAFT
WINDOWS/WINDSHIELDS**

FEBRUARY 1996

**TECHNICAL REPORT FOR 09/91 - 12/31/95
CONTRACT NUMBER FO9603-90-D-2217-SD02**

**PREPARED FOR
OKLAHOMA CITY AIR LOGISTICS CENTER
TINKER AFB, OK 73145**

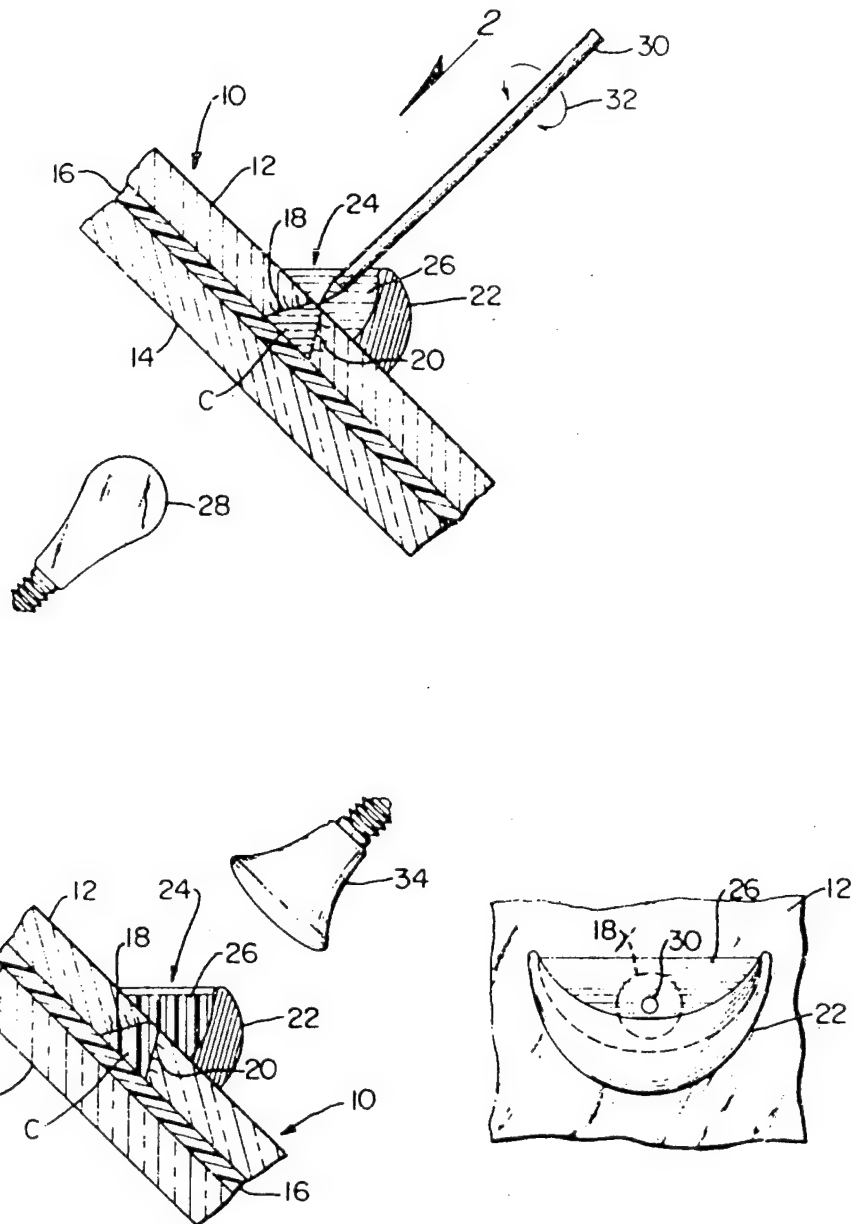
Figure 3.1 The Glass Doctor Patented Technique for Repair of Conical cracks in Laminated Glass, U.S. Patent #3,841,932

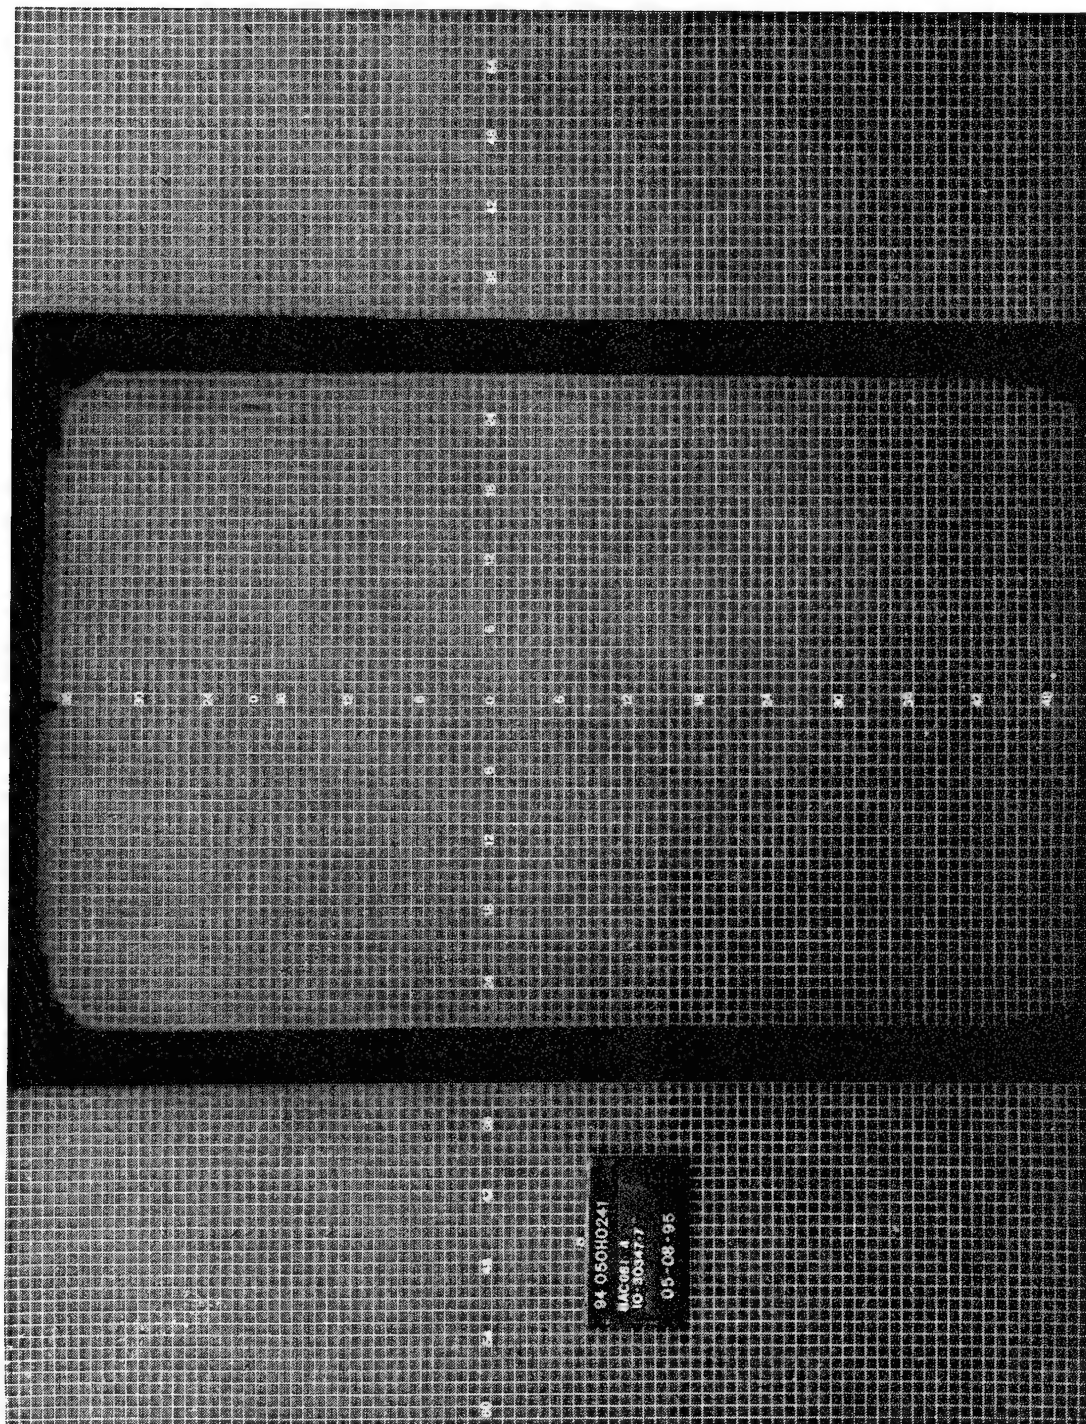
Figure 4.1 Worst B-52 #1 W/WS Optical Distortion (S/N 94-050-HO-241)

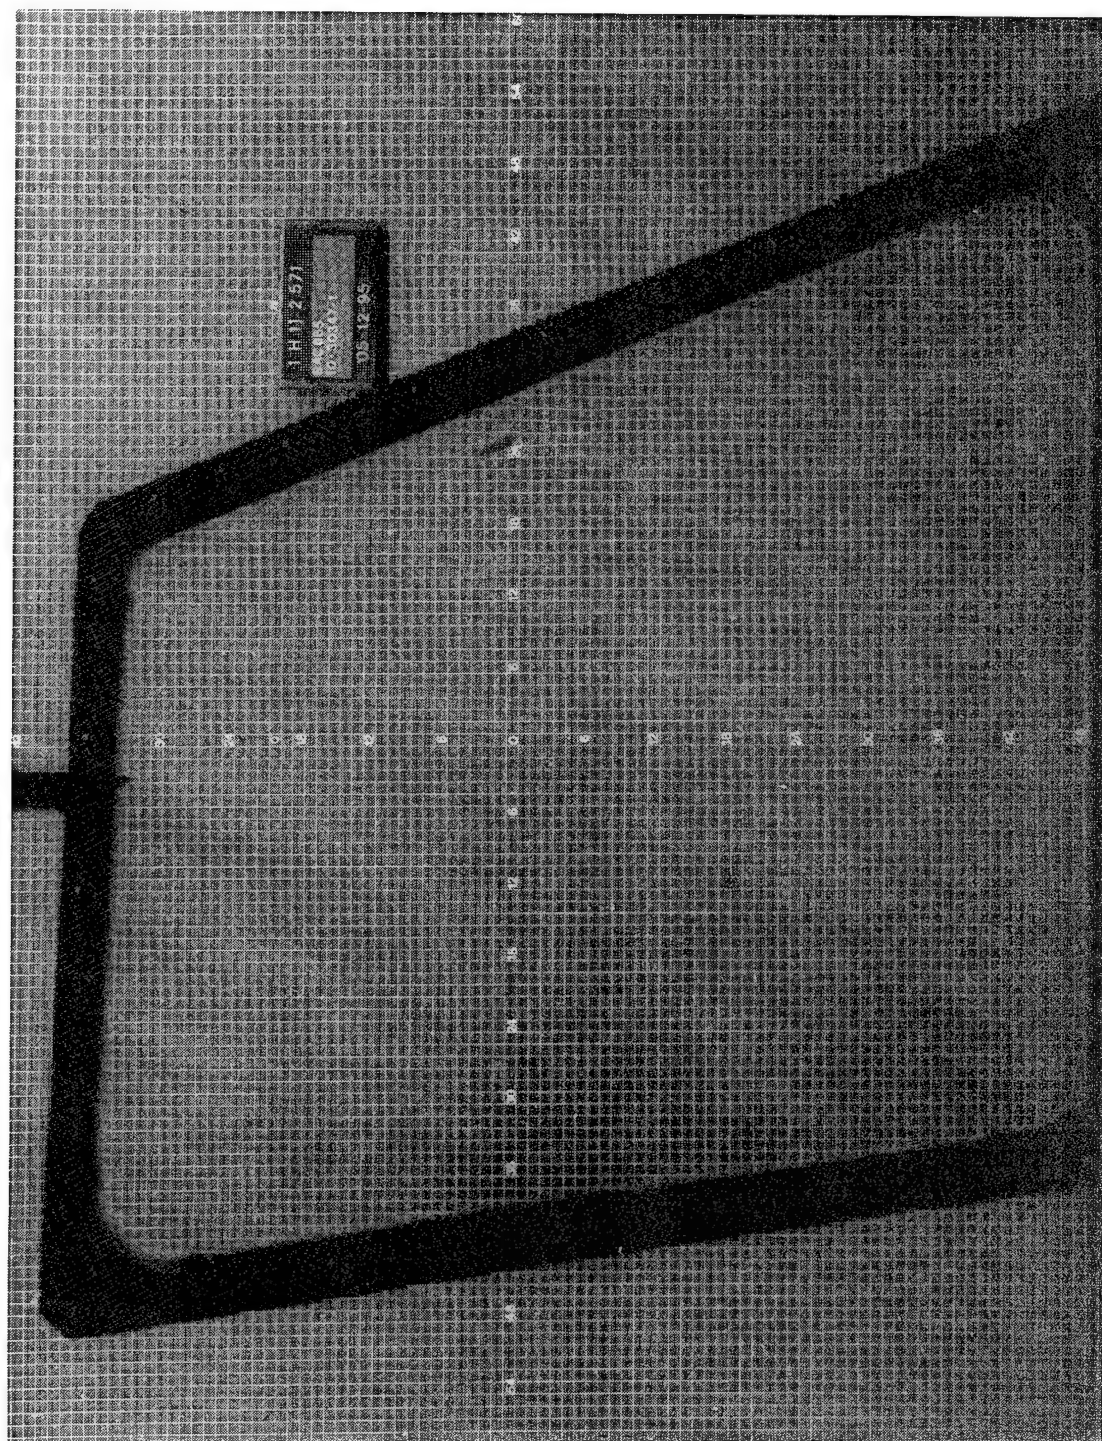
Figure 4.2 Worst B-52 #2 W/WS Optical Distortion (S/N 1-H-11-2-571)

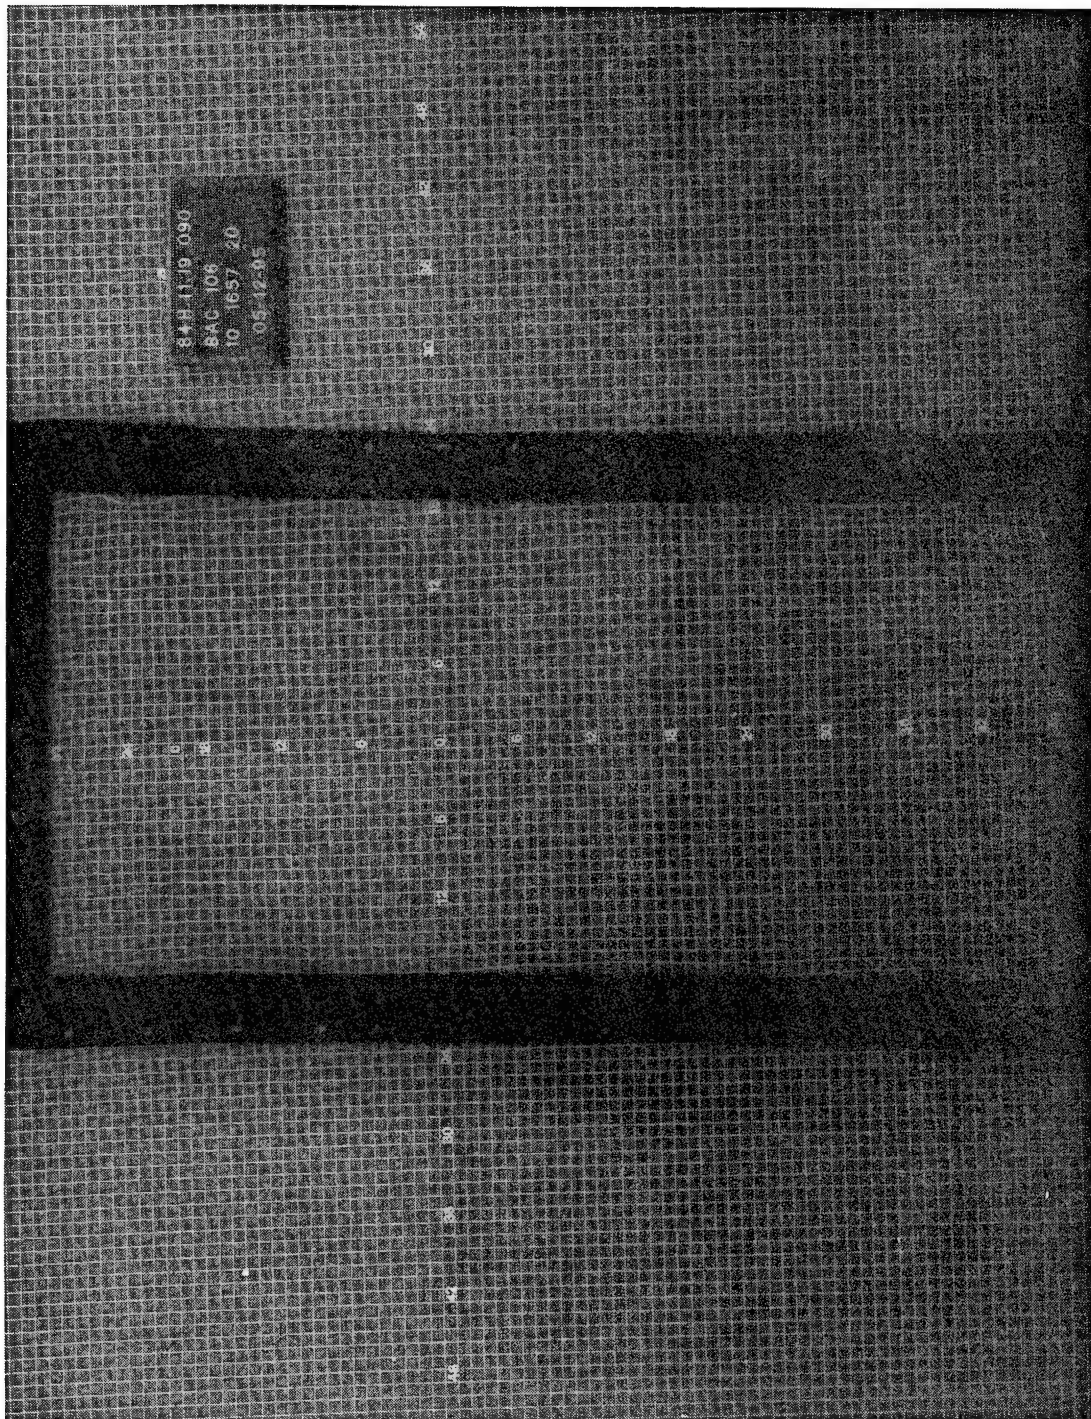
Figure 4.3 Worst B-52 Escape Hatch Optical Distortion (S/N 84-H-11-19-090)

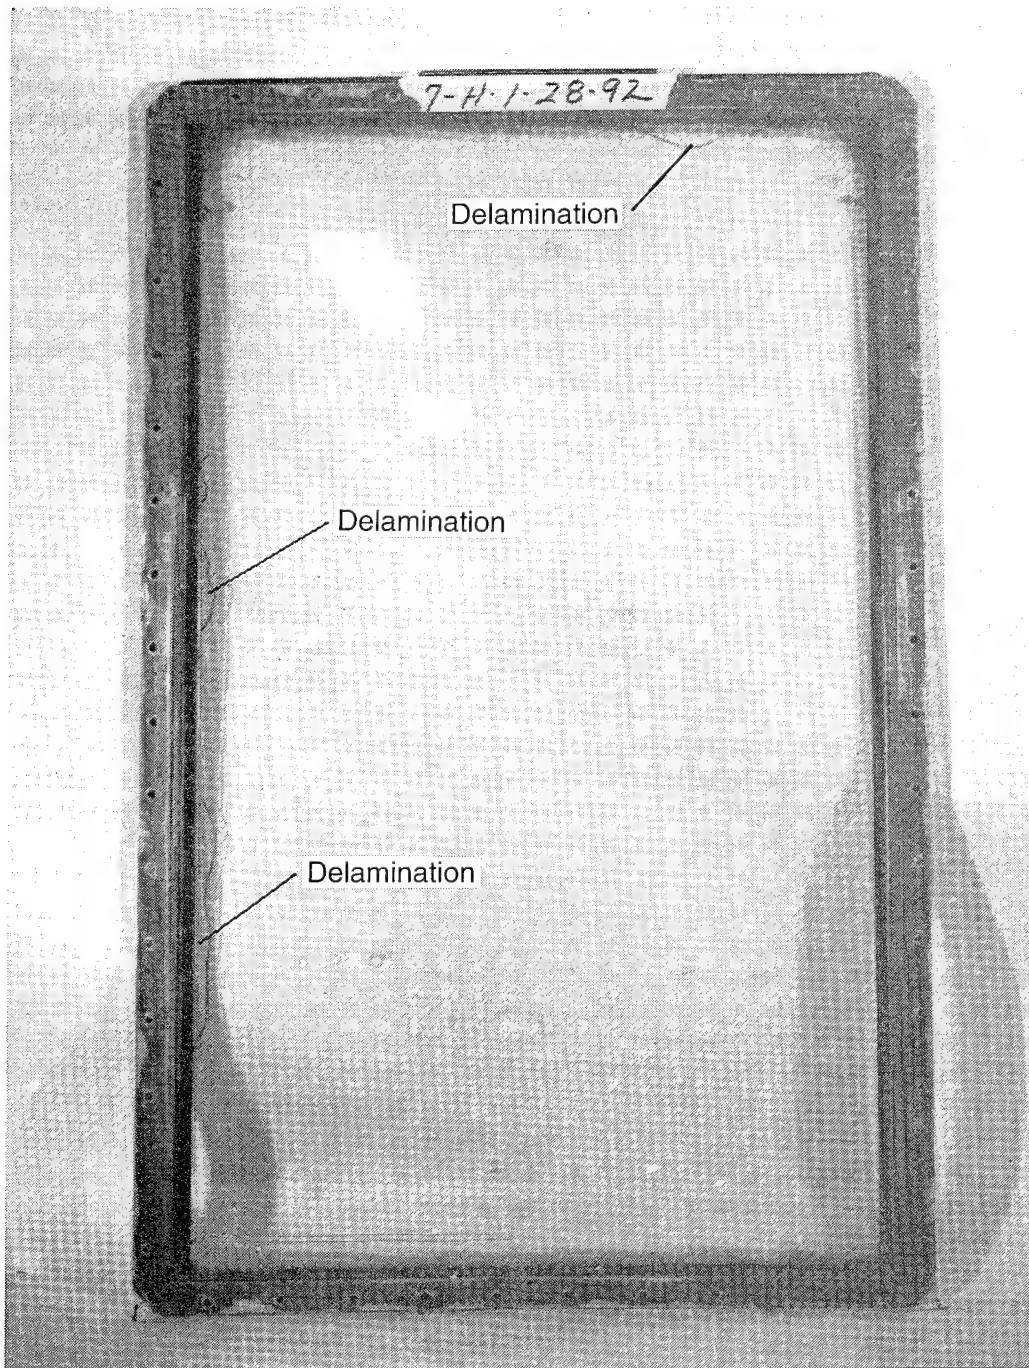
Figure 4.6 Worst B-52 #1 W/WS Delamination (S/N 7-H-1-28-92)

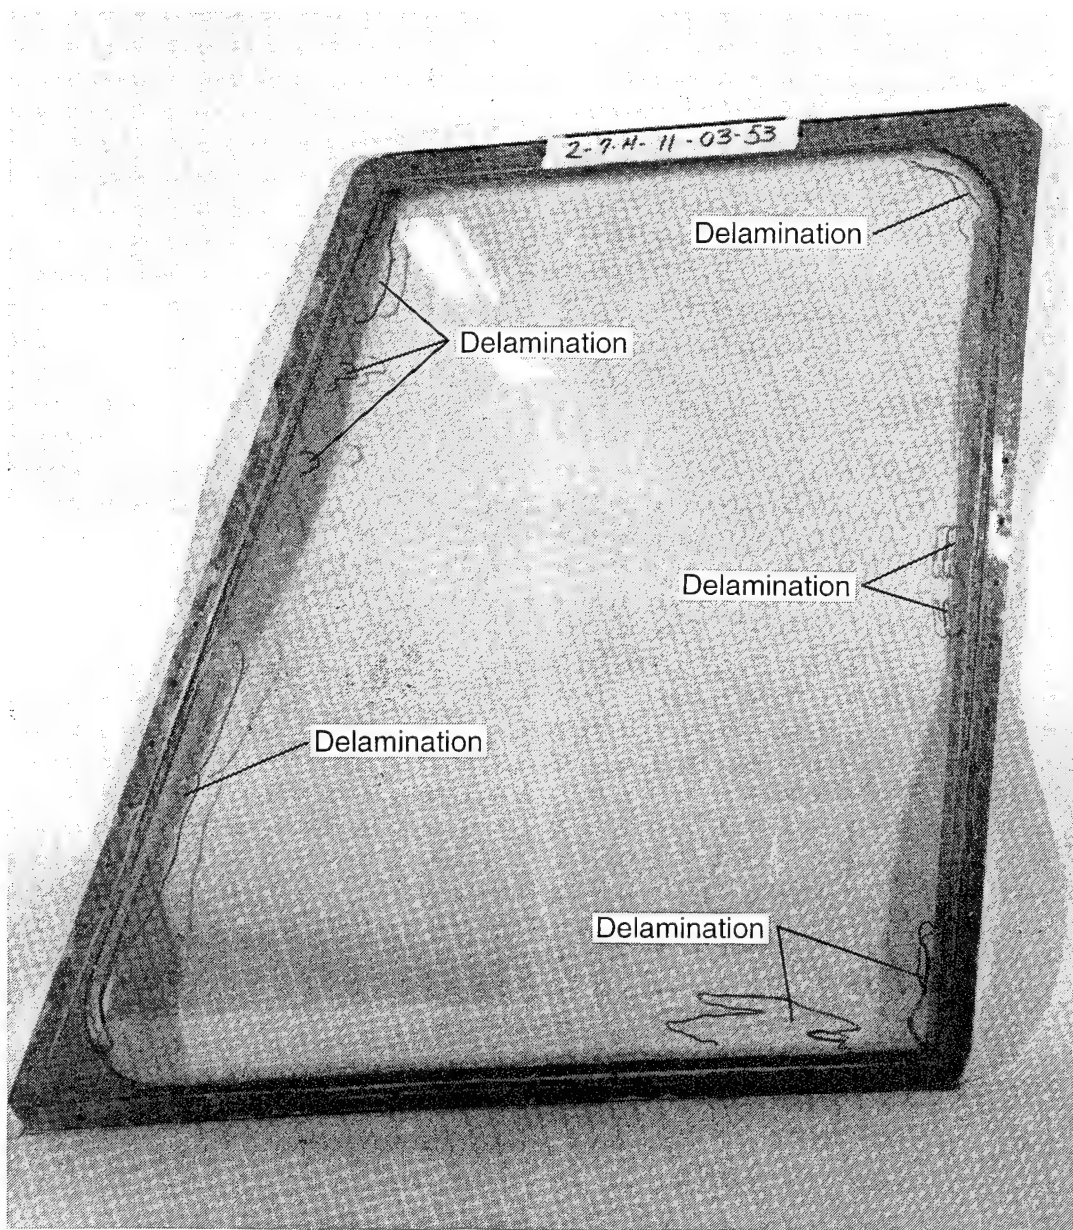
Figure 4.7 Worst B-52 #2 W/WS Delamination (S/N 7-H-11-03-53)

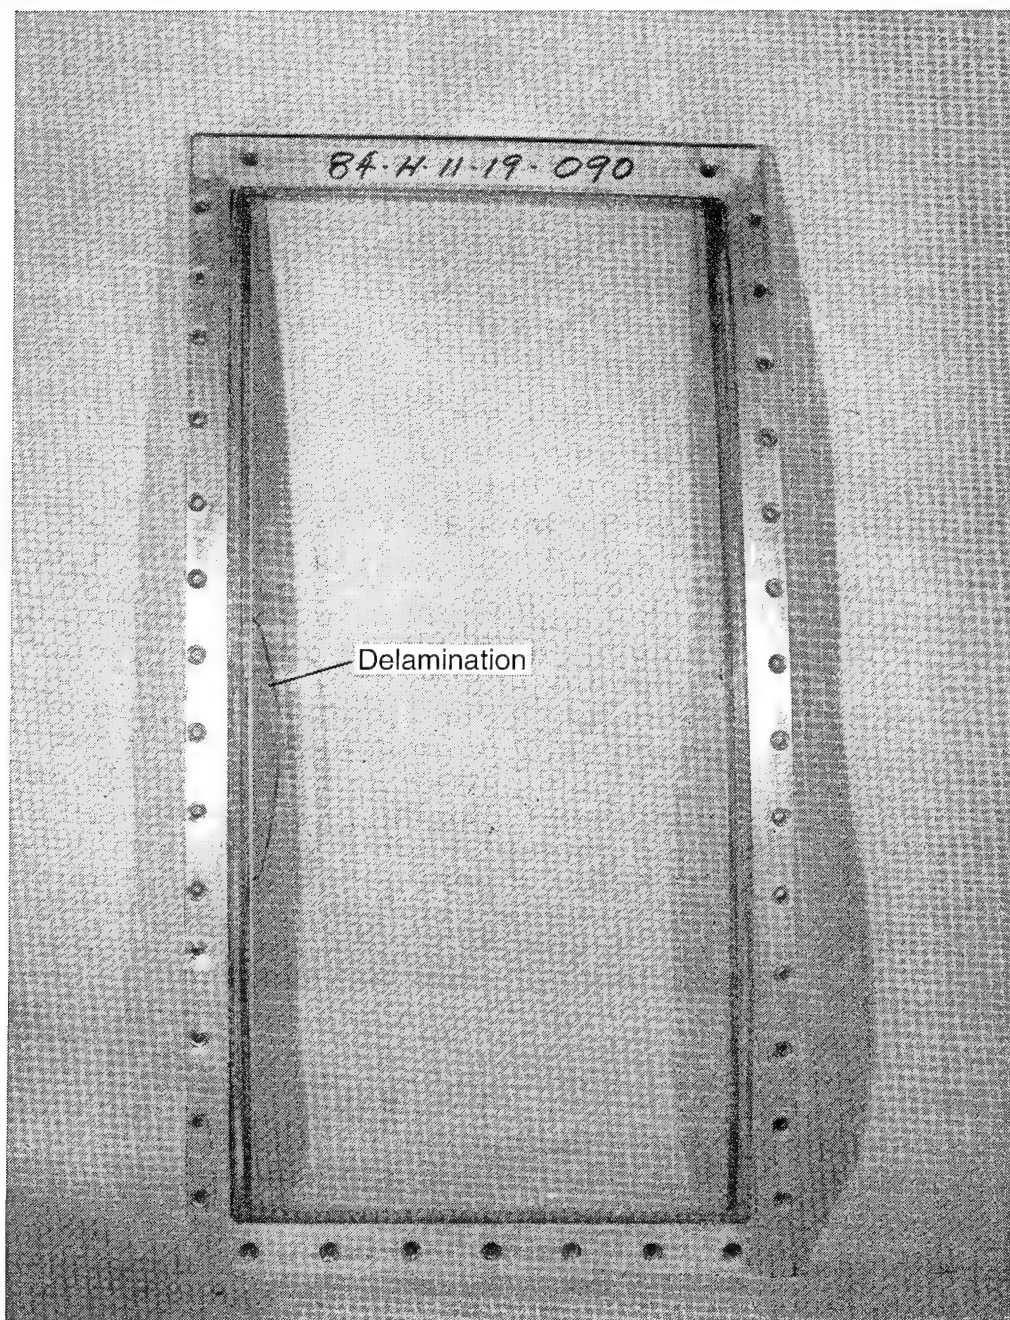
Figure 4.8 Worst B-52 Escape Hatch Delamination (S/N 84-H-11-19-090)

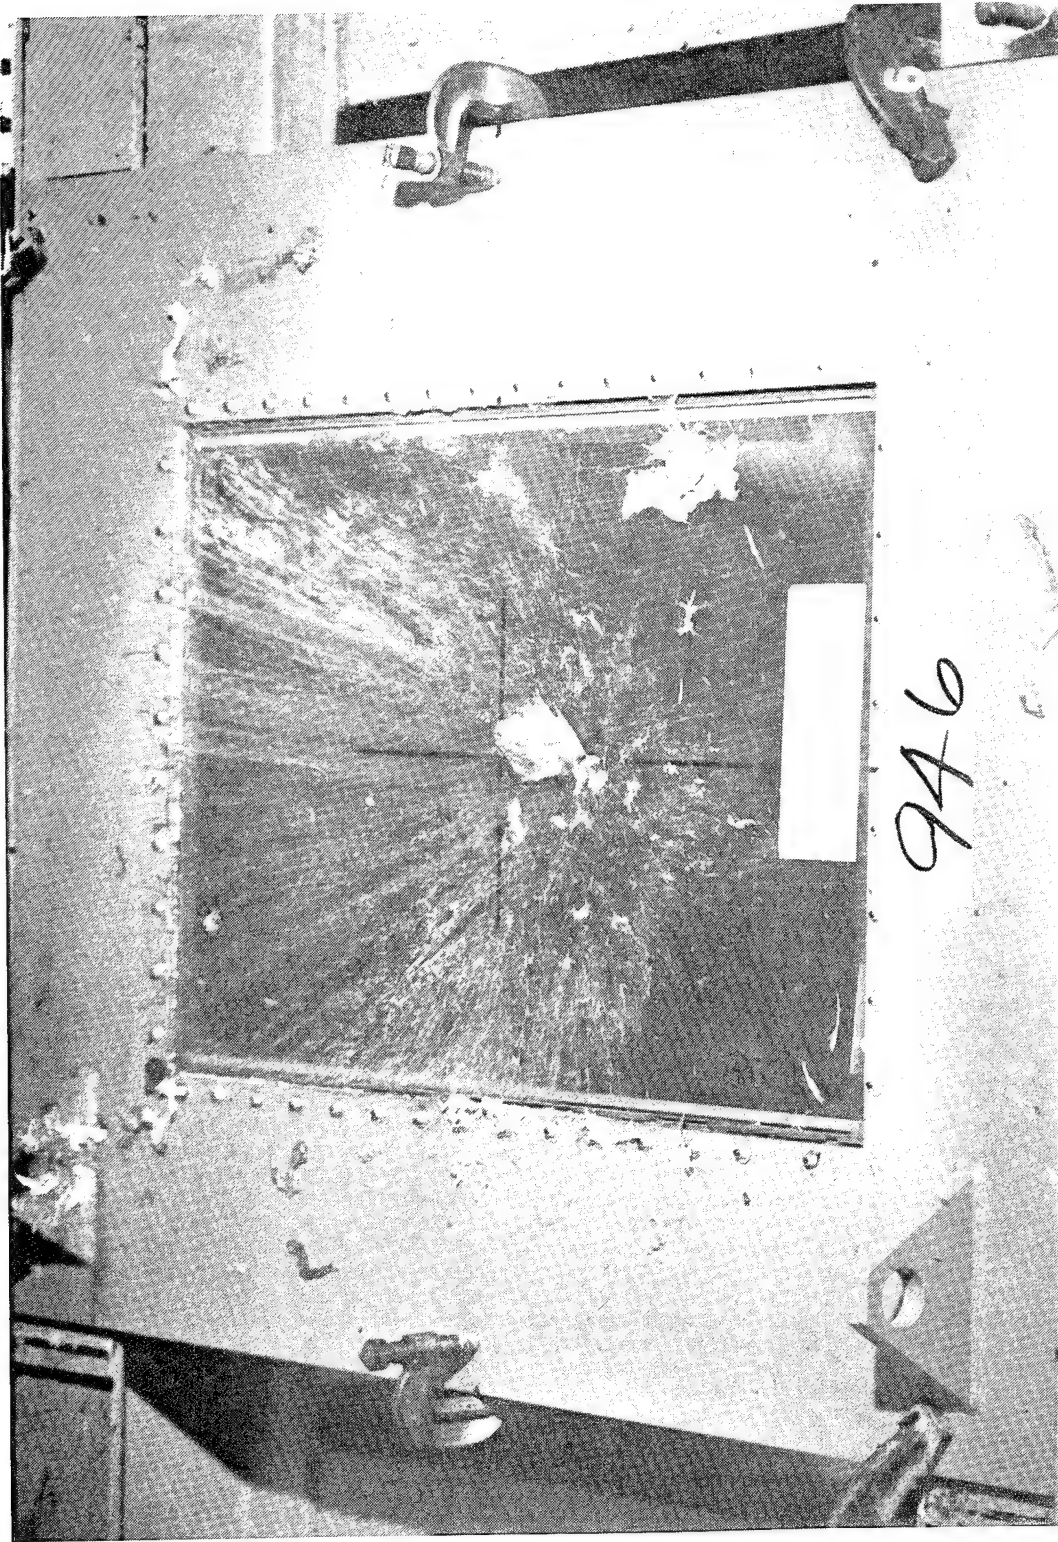
Figure 4.12 B-52 #1 W/WS Showing No Damage From a 4-Pound Bird Impact at 251 knots (S/N 87-H-11-30-749)

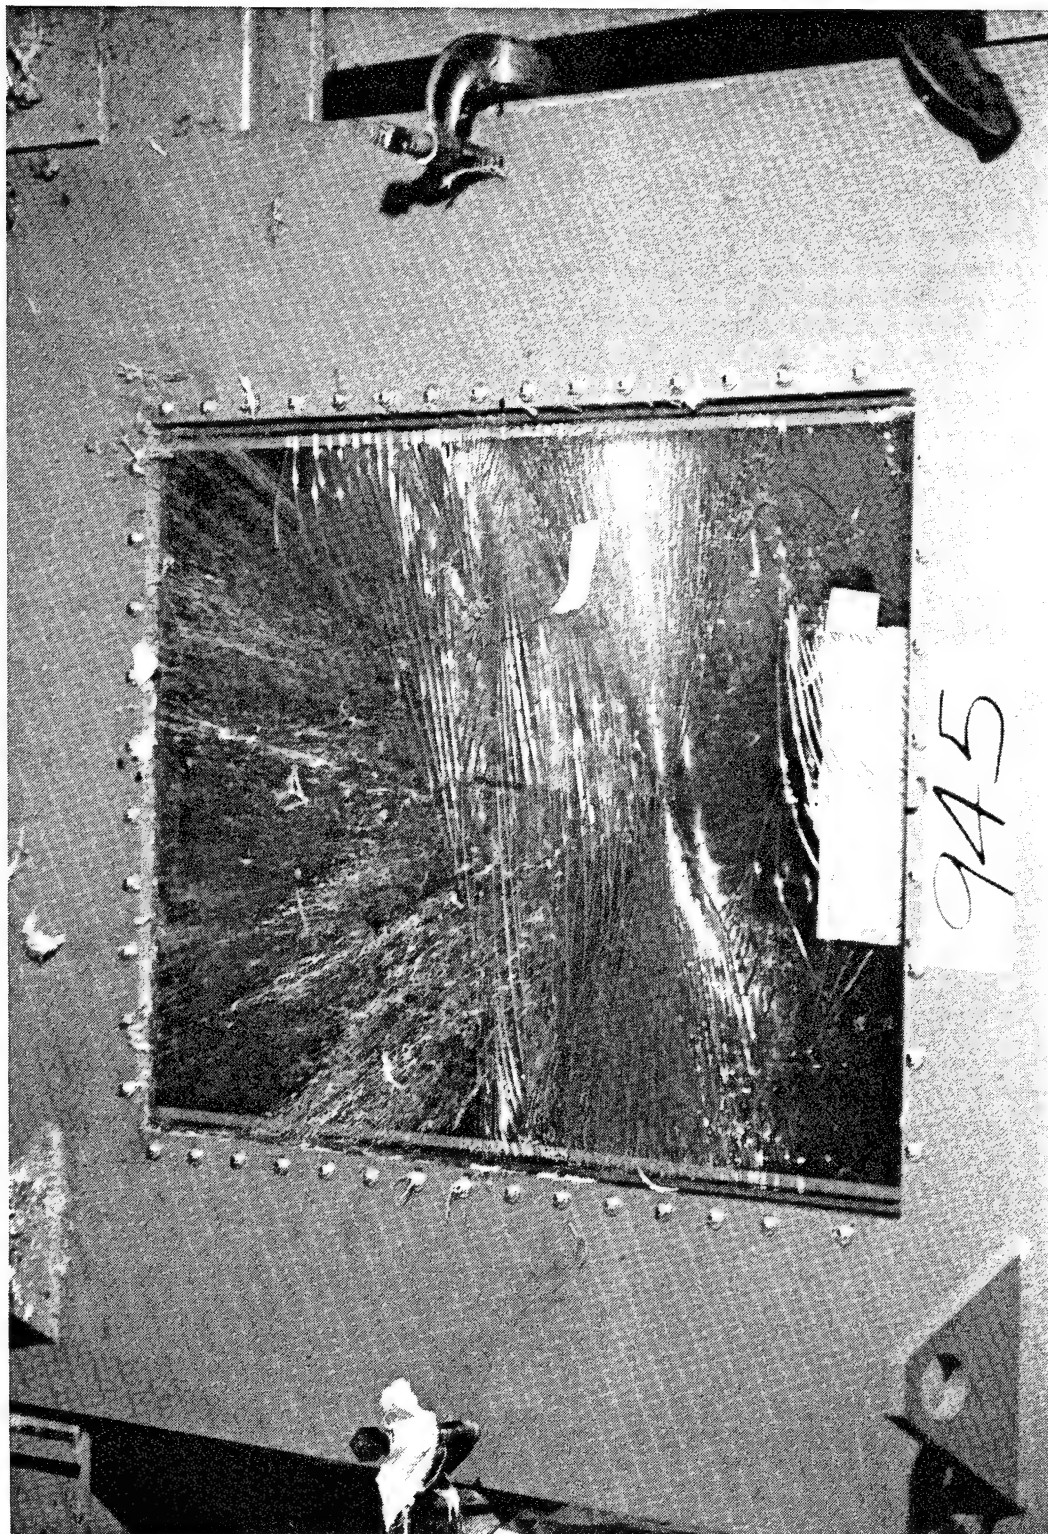
Figure 4.13 B-52 #1 W/WS Showing Outboard Ply Failure From a 4-Pound Bird Impact at 212 knots (S/N 86-H-03-03-298)

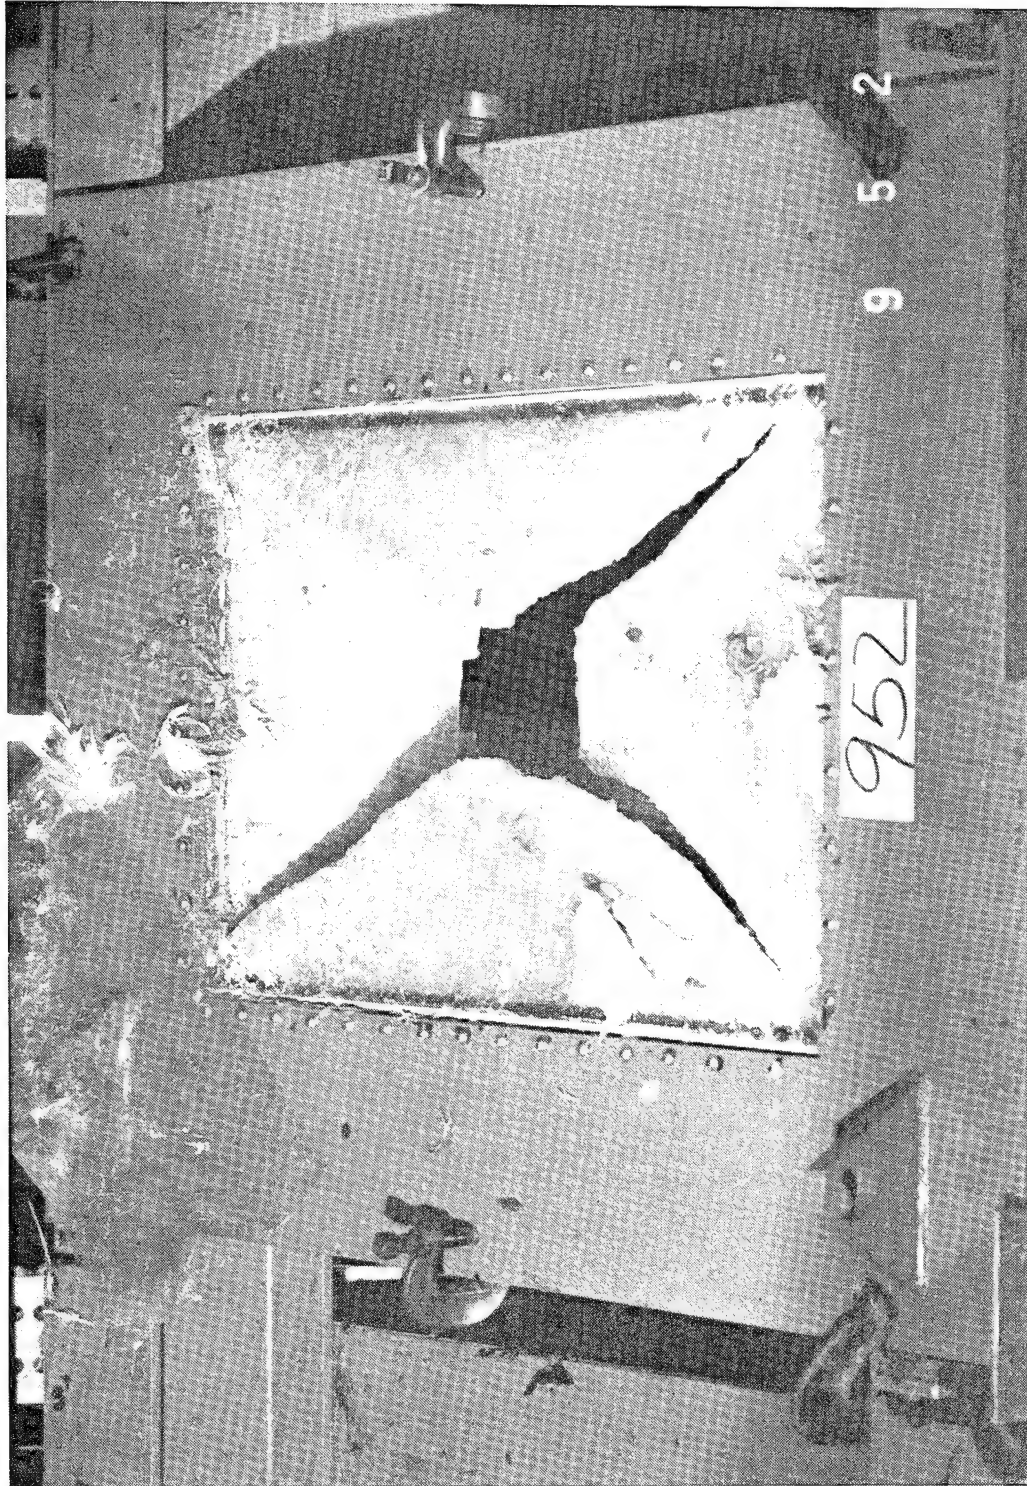
Figure 4.14 B-52 #1 W/WS Showing Worst Damage (Complete Transparency Failure) From a 4-Pound Bird Impact at 250 knots (S/N 86-H-04-28-693)

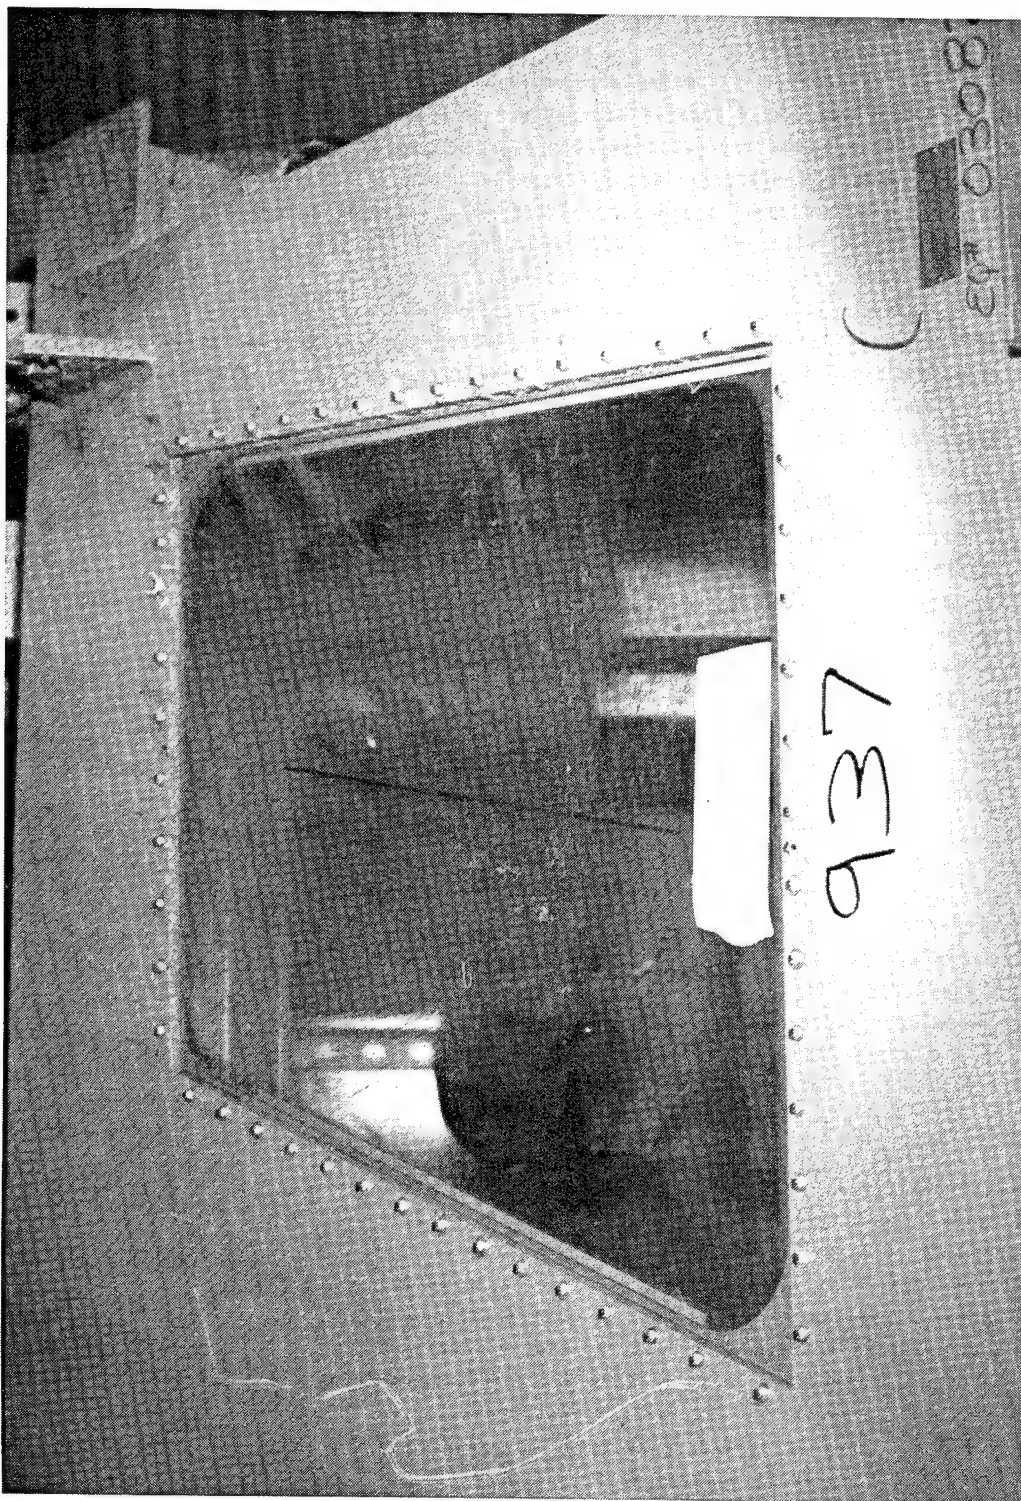
Figure 4.15 B-52 #2 W/WS Showing No Damage From a 4-Pound Bird Impact at 309 knots (S/N 92-199-HO-423)

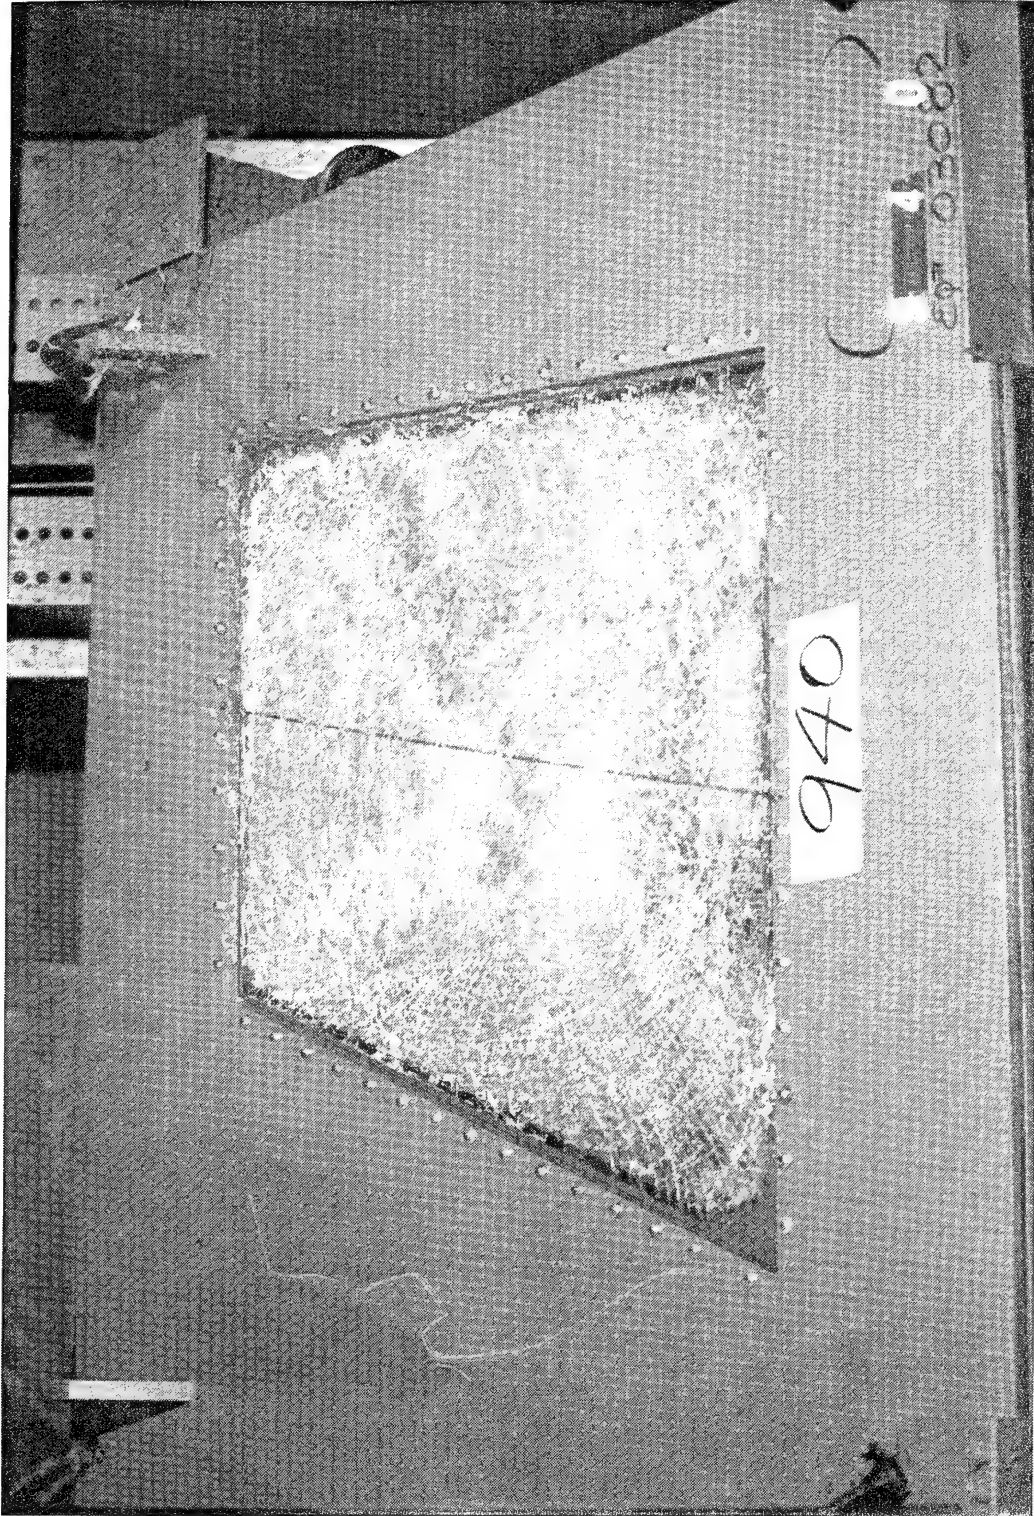
Figure 4.16 B-52 #2 W/WS Showing Outboard Ply Failure From a 4-Pound Bird Impact at 306 knots (S/N 5-H-3-04-09)

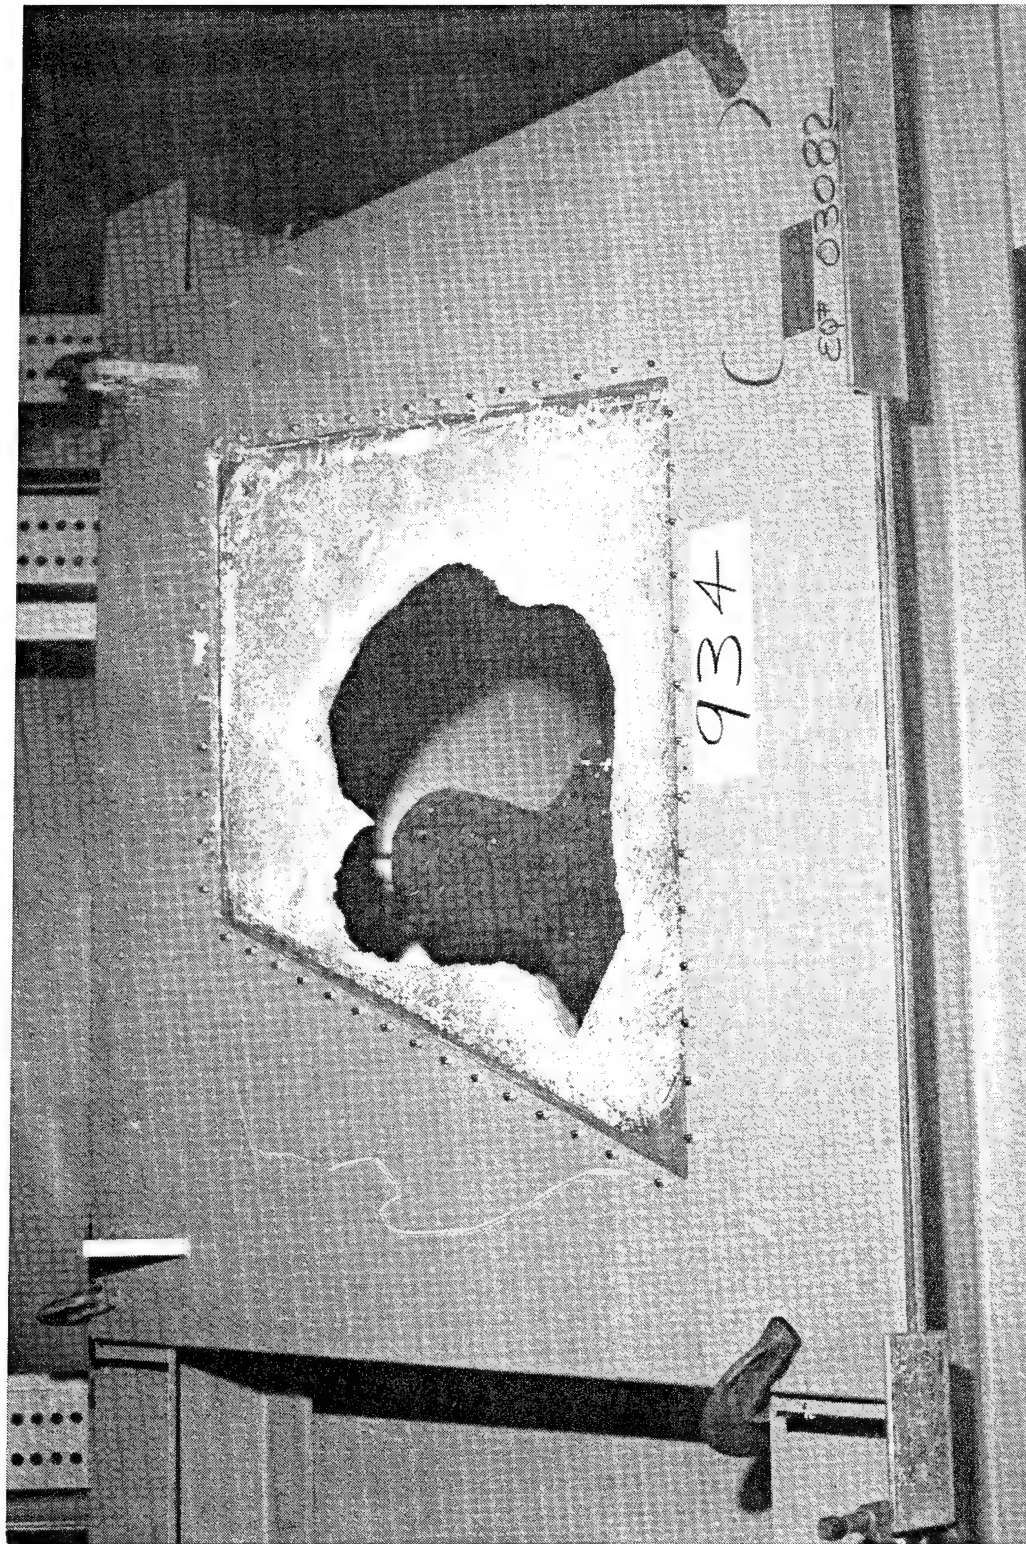
Figure 4.17 B-52 #2 W/WS Showing Worst Damage (Complete Transparency Failure) From a 4-Pound Bird Impact at 403 knots (S/N 8-H-11-20-277)
